# Property Inspection Report

1234 Your Happy Home,  
Your Town, OH

DATE OF INSPECTION: 10/23/2023

**ClearVIEW**  
INSPECTION GROUP

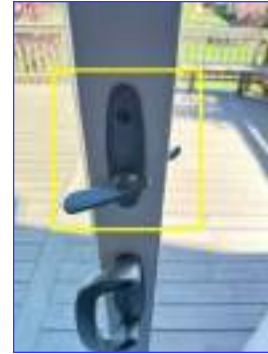
- Materials: Metal Clad • Sliding Glass Door
- **Inoperable latch- The sliding glass door had an inoperable latch. The Inspector recommends service by a qualified contractor.**

Inoperable latch

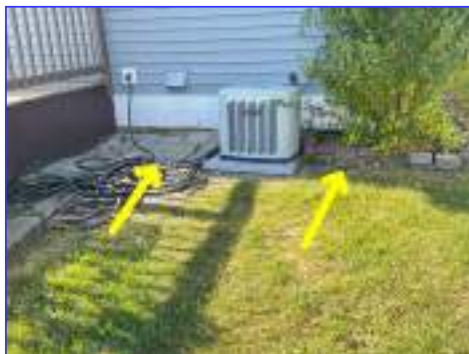
Adding dirt backfill to any low lying areas located around the foundation is recommended to ensure proper drainage away from the foundation at all times.

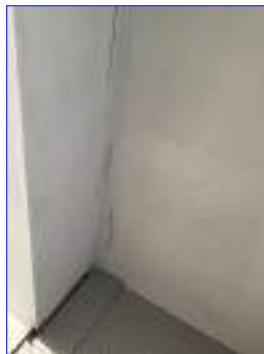
Cracking and peeling observed, recommend review for repair. No water stains observed at the time of inspection.

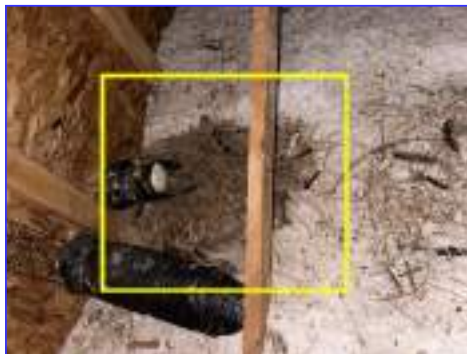
- The bathroom exhaust ducts are separated, damaged and contaminated from wildfire. Replacement suggested.

The bathroom exhaust ducts are separated, damaged and contaminated from wildfire. Replacement suggested.

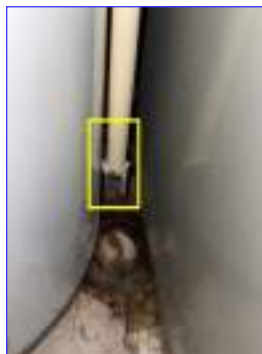
- The water heater is equipped with a mandated pressure-temperature relief valve.
- **The pressure relief valve was leaking at the time of the inspection and should be replaced by a qualified HVAC technician or plumbing contractor.**

The pressure relief valve was leaking

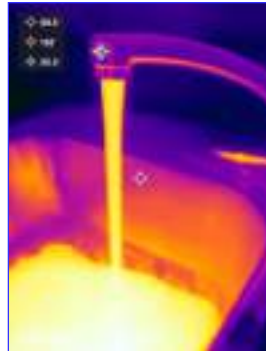
- The hot water temperature was (132) degrees at the time of inspection. This can be a scald hazard. Recommend lowering water temperature for improved safety. Hot water temperatures should not exceed 120 degrees F.

The hot water temperature was (132) degrees at the time of inspection. This can be a scald hazard. Recommend lowering water temperature for improved safety. Hot water temperatures should not exceed 120 degrees F.

Page 19	Water Temperature Observations	• The hot water temperature was (132) degrees at the time of inspection. This can be a scald hazard. Recommend lowering water temperature for improved safety. Hot water temperatures should not exceed 120 degrees F.
Page 19	Water Heater Comments	• The water heater is beyond its warranty period.
<b>General Gas Components</b>		
Page 20	Gas Pipe Observations	• The <b>CSSI</b> (corrugated stainless steel tubing) in the home were not bonded to the home electrical system. This condition is improper. The Inspector recommends correction by a qualified electrical contractor.

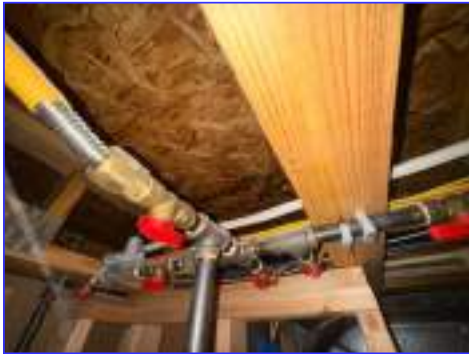
- The **cssi** (corrugated stainless steel tubing) in the home were not bonded to the home electrical system. This condition is improper. The Inspector recommends correction by a qualified electrical contractor.

The csst (corrugated stainless steel tubing) in the home were not bonded

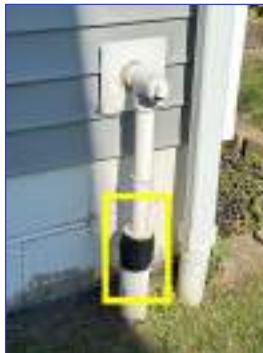
The sump pump discharge pipe is damaged, improperly repaired with duct tape and should be serviced or replaced.

Page 20	Sump Pump Observations	• The sump pump discharge pipe is damaged, improperly repaired with duct tape and should be serviced or replaced.
---------	------------------------	---

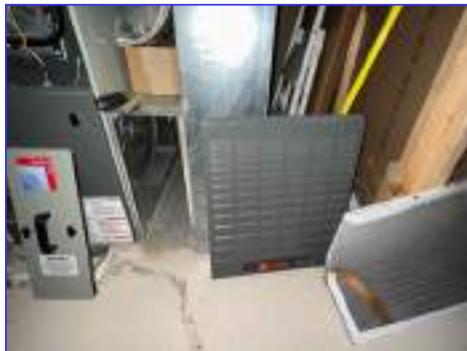
- The return-air compartments are in acceptable condition.
- Wrong size filter installed, filter was being sucked into the circulation fan and removed. Suggest installing proper size filter for proper air filtration.

Wrong size filter installed, filter was being sucked into the circulation fan and removed. Suggest installing proper size filter for proper air filtration.

Page 23	Return Air Compartment Observations	• Wrong size filter installed, filter was being sucked into the circulation fan and removed. Suggest installing proper size filter for proper air filtration.
Page 24	Condensing Coil Observations	• The condensing coil has reached its designed life expectancy. We make no warranty, guarantee or estimation as to the remaining useful life of this unit.
Page 24	Thermostat Observation	• Broken, replace- The thermostat was broken and needed replacement at the time of the inspection. The Inspector recommends replacement by a qualified HVAC contractor.
Page 25	Refrigerant Lines Observations	• The refrigerant line is kinked or damaged at the condensing coils which will restrict the flow of refrigerant. Recommend review by a qualified professional for repair or replacement, as necessary, prior to close.

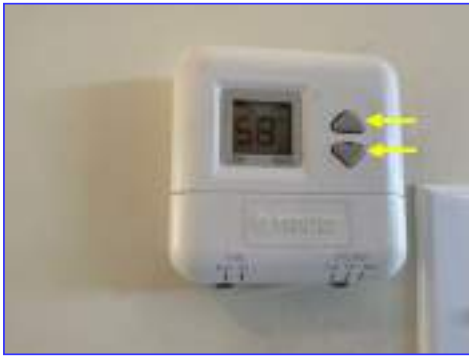
- Broken, replace- The thermostat was broken and needed replacement at the time of the inspection. The Inspector recommends replacement by a qualified HVAC contractor.

Broken, replace- The thermostat was broken and needed replacement at the time of the inspection.

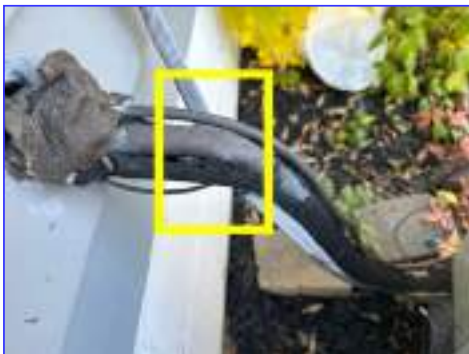
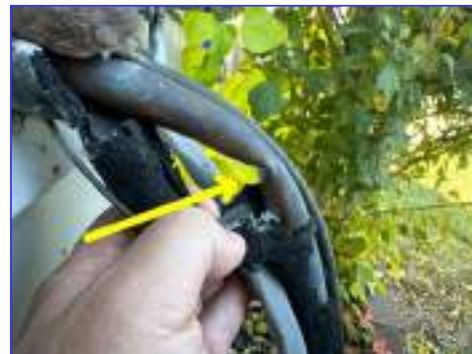
- The refrigerant line is kinked or damaged at the condensing coils which will restrict the flow of refrigerant. Recommend review by a qualified professional for repair or replacement, as necessary, prior to close.

The refrigerant line is kinked or damaged at the condensing coils which will restrict the flow of refrigerant.

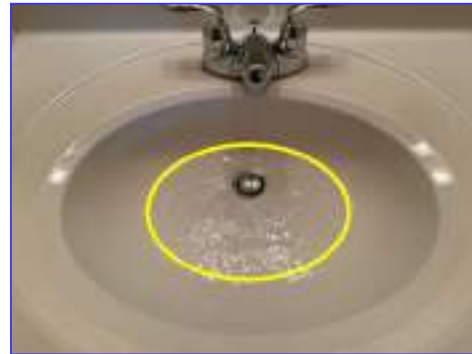
||4||The sink drain is slow or partially blocked and should be serviced.

Page 39	Traps & Drains Observations	• The sink drain is slow or partially blocked and should be serviced.
---------	-----------------------------	---

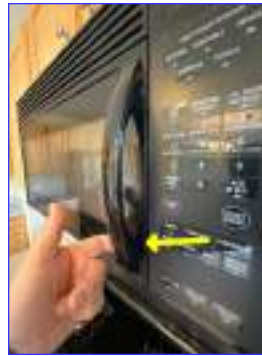
- The built-in microwave is functional.
- The microwave door has a broken handle, service or replacement suggested.

||4||The microwave door has a broken handle, service or replacement suggested.

Page 42	Microwave Observations	• The microwave door has a broken handle, service or replacement suggested.
---------	------------------------	---

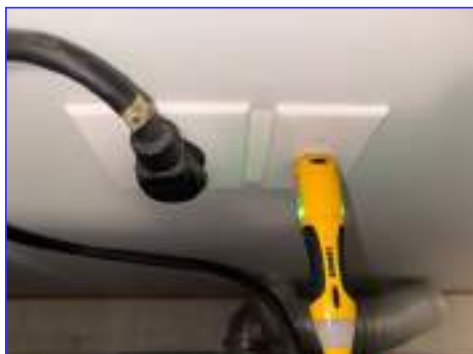
No ground fault circuit interrupter (**GFCI**) protection of electrical receptacles observed. **GFCI** protection may not have been required at the time the home was built, for safety reasons, the Inspector recommends that the home electrical system be upgraded to meet modern safety standards. All work should be performed by a qualified electrical contractor.

No ground fault circuit interrupter (GFCI) protection of electrical receptacles observed.

Page 43	Outlets Observations	• No <b>GFCI</b> . No ground fault circuit interrupter ( <b>GFCI</b> ) protection of electrical receptacles observed. <b>GFCI</b> protection may not have been required at the time the home was built, for safety reasons, the Inspector recommends that the home electrical system be upgraded to meet modern safety standards. All work should be performed by a qualified electrical contractor.
---------	----------------------	--
