# Property Inspection Report

Your Happy Home,  
Your Town, OH

DATE OF INSPECTION: 10/12/2023

**ClearVIEW**  
INSPECTION GROUP

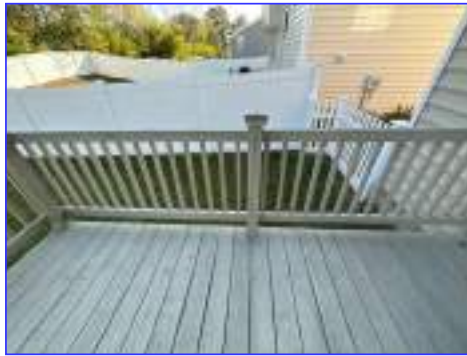
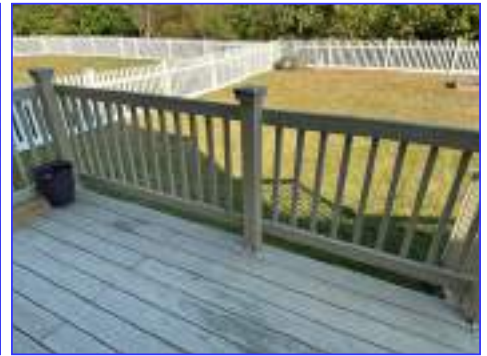
**The deck guardrail assemblies were loose and should be made secure by a qualified contractor.**

Lose guardrail

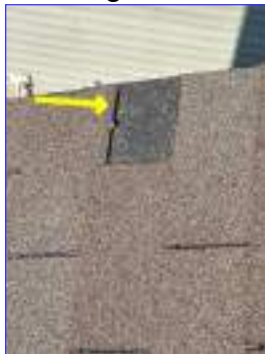
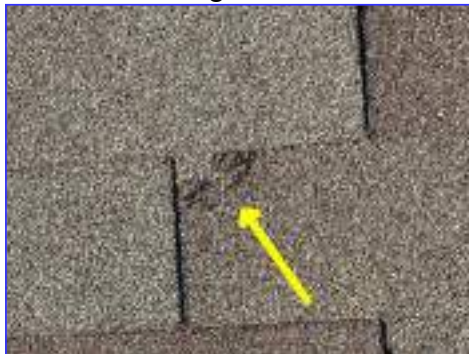
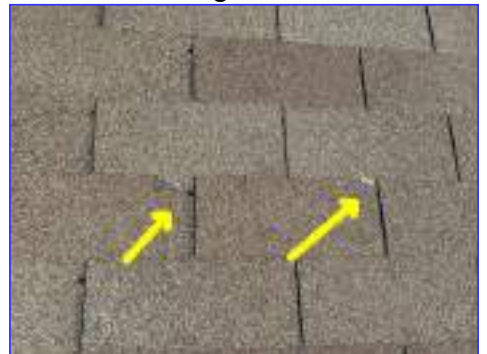
- Exposed fasteners observed at the ridge cap / vent. All exposed nails should be properly sealed because they are a potential cause of roofing leaks.
- Loose/missing or damaged shingles- The roof had loose, missing or damaged asphalt shingles. The Inspector recommends replacement of any loose or missing shingles by a qualified roofing contractor to avoid damage from moisture intrusion.

Loose/missing or damaged shingles

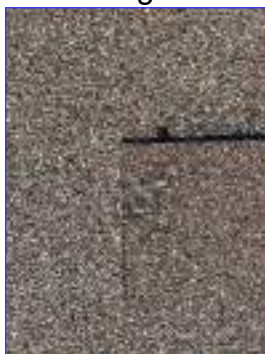
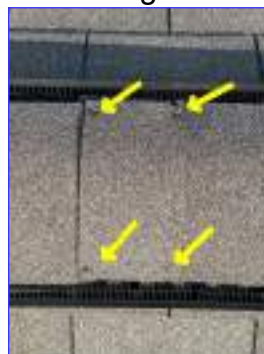
Exposed fasteners

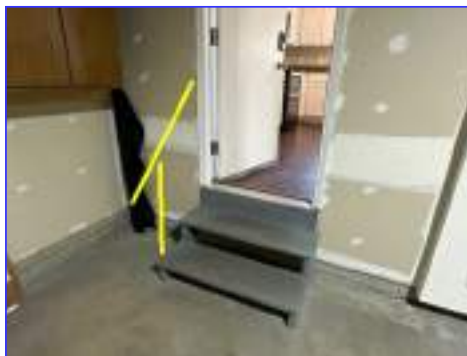
As a safety precaution, we recommend installing handrails on steps that have three or more risers, and particularly if children or the elderly visit or occupy the property.

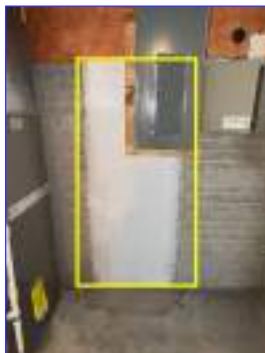
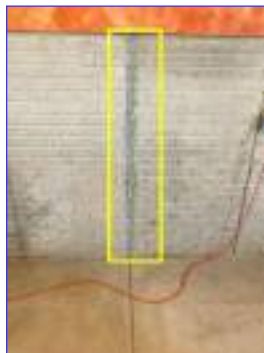
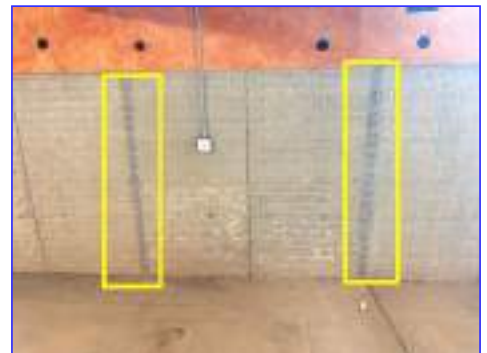
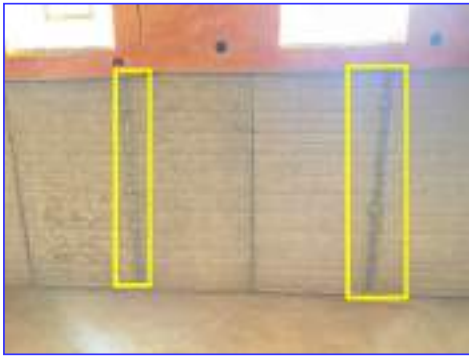
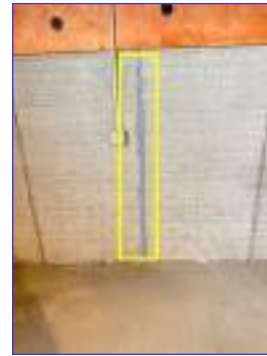
- The foundation wall(s) have been serviced, we recommend that you obtain documentation for your records, which will confirm that the work was done by professionals. This is important because our inspection does not tacitly approve, endorse, or guarantee the integrity of any work that was done without a permit, and latent defects may exist.

Service or repairs observed.

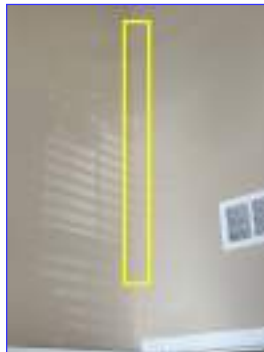
- Cracking and peeling observed, recommend review for repair. No water stains observed at the time of inspection.

Cracking and peeling observed

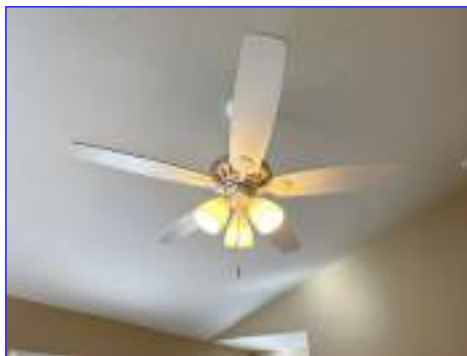
- Ceiling fan inoperable- A ceiling fan was inoperable. The Inspector recommends an evaluation and any necessary work be performed by a qualified electrical contractor.

Ceiling fan inoperable

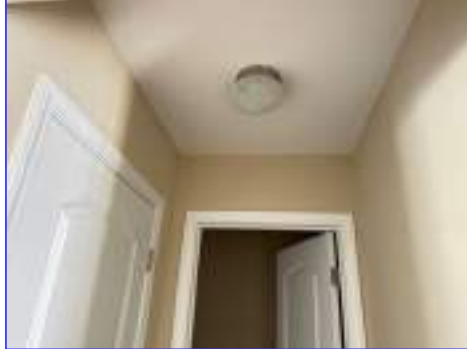
- A ceiling light does not respond and should be serviced.

||4||A ceiling light does not respond and should be serviced.
