# Property Inspection Report

1234 Your Happy Home,  
Your Town, OH

DATE OF INSPECTION: 10/23/2023

**ClearVIEW**  
INSPECTION GROUP

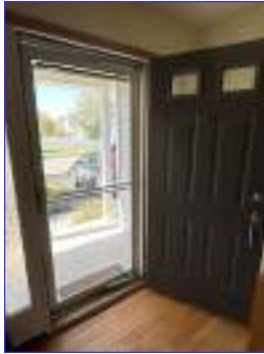
- Materials: Metal Clad • Sliding Glass Door
- **Inoperable latch- The sliding glass door had an inoperable latch. The Inspector recommends service by a qualified contractor.**

The exterior door(s) are in satisfactory condition

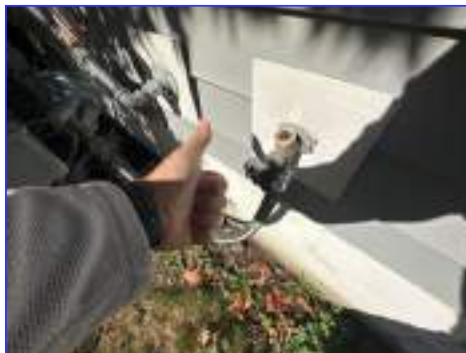
The exterior faucets are functional.

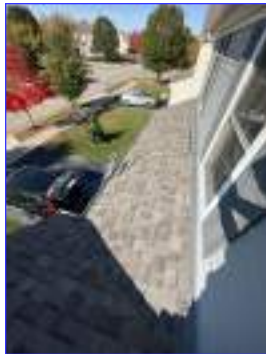
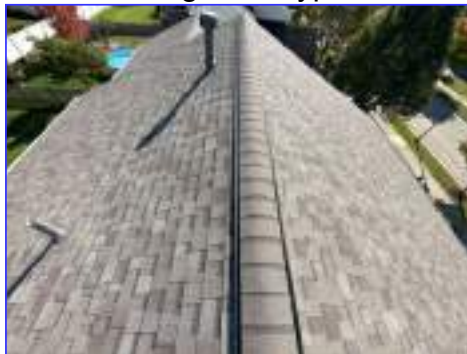
The roof shows normal wear for its age and type.

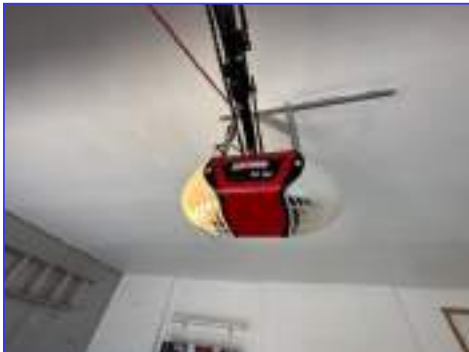
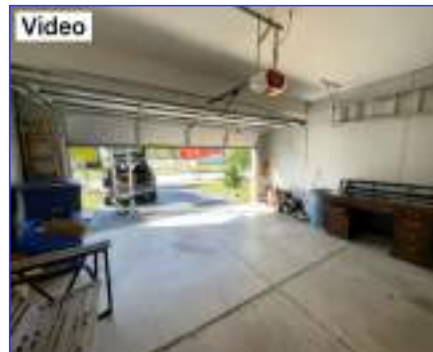
The garage door opener is functional.

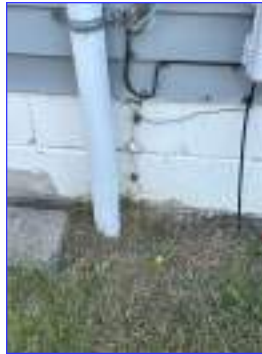
The panel is grounded to a driven rod.

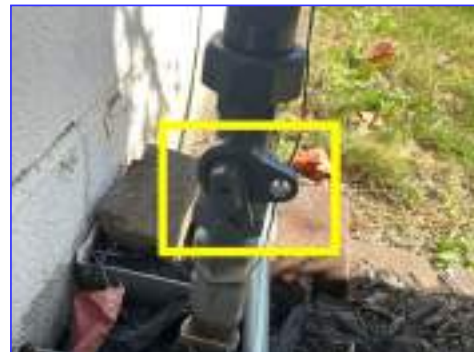
Main gas shut-off.

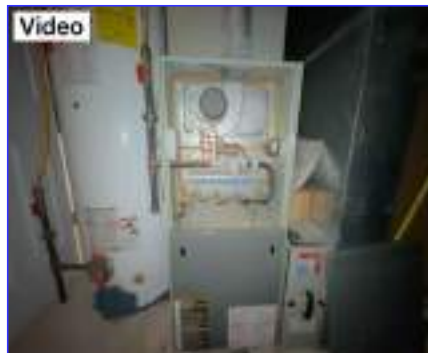
- Combustion chamber OK- Conditions in the furnace combustion chamber appeared to be acceptable at the time of the inspection. Some of the combustion chamber was not visible. A full evaluation of the combustion chamber would require the services of a qualified heating, ventilation and air-conditioning (HVAC) contractor.

Combustion chamber OK

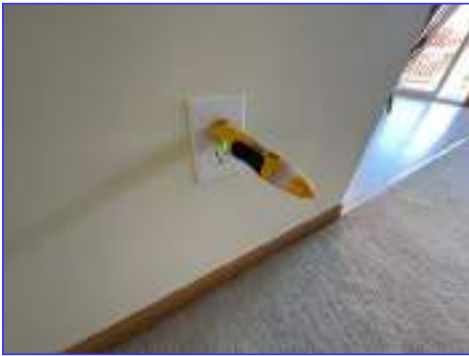
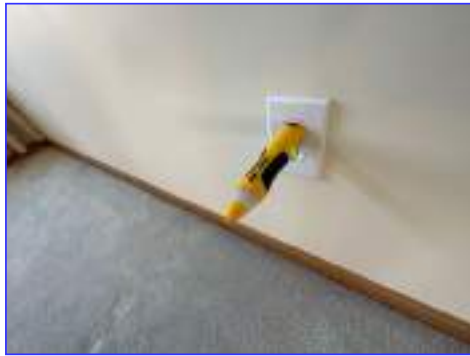
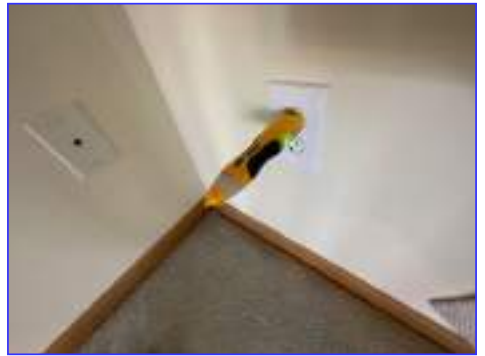
The outlets that were tested are functional.

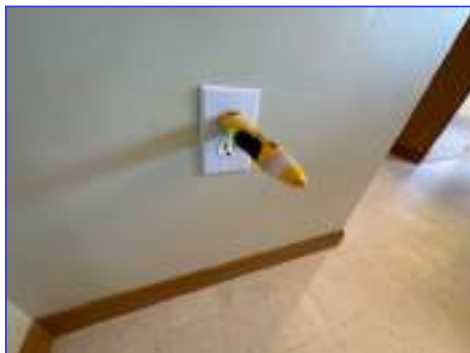
The outlets that were tested are functional.

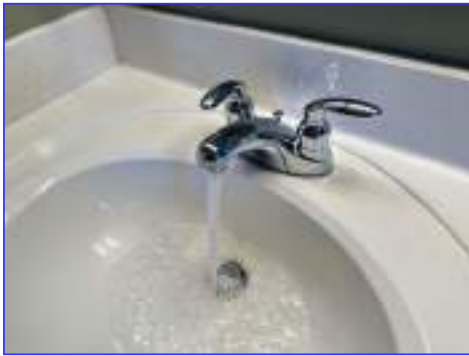
The Faucet is functional.

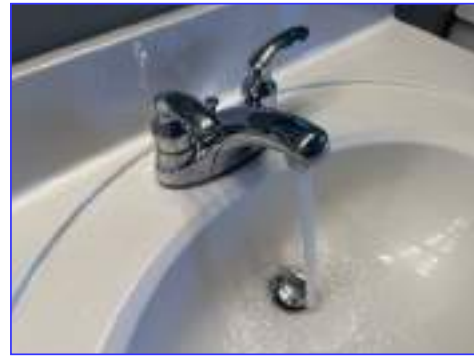
The Faucet is functional.

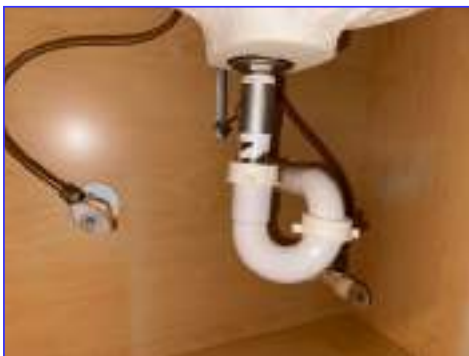
The drain assembly appears to be in satisfactory condition with no visible leaks or deficiencies.

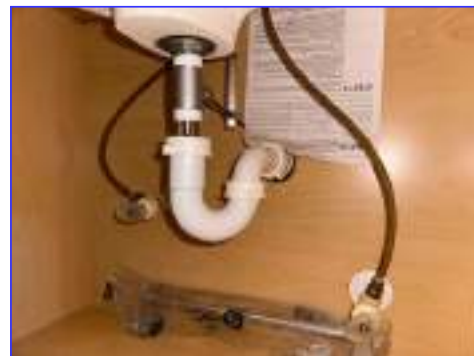
The drain assembly appears to be in satisfactory condition with no visible leaks or deficiencies.

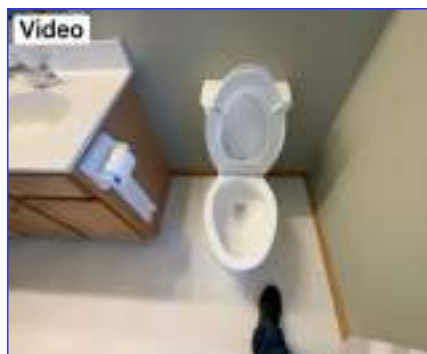
The toilet is functional with no visible leaks or deficiencies.

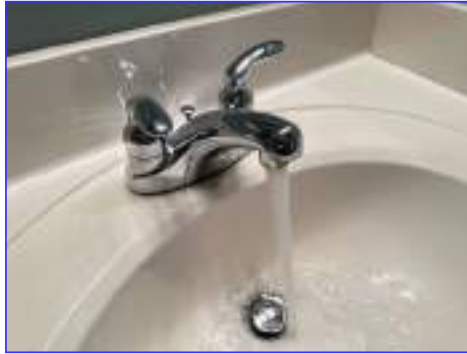
The Faucet is functional.

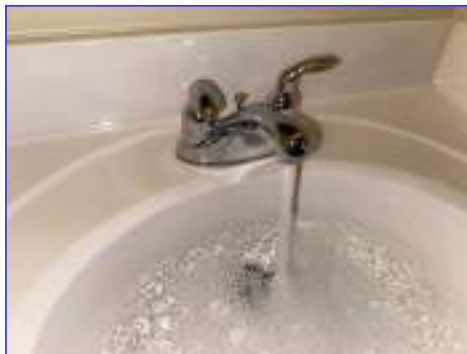
The Faucet is functional.

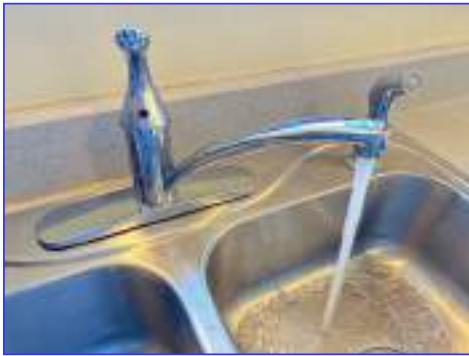
The Faucet is functional.

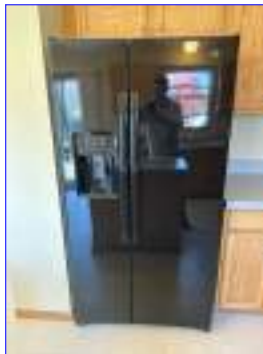
The refrigerator and freezer are functional.

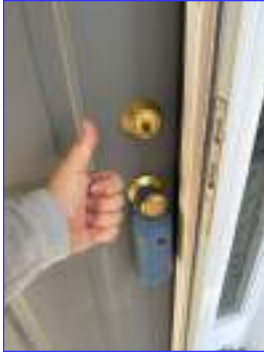
The doors are secure
