# Property Inspection Report

1234 Your Happy Home,  
Your Town, OH

DATE OF INSPECTION: 10/23/2023

**ClearVIEW**  
INSPECTION GROUP

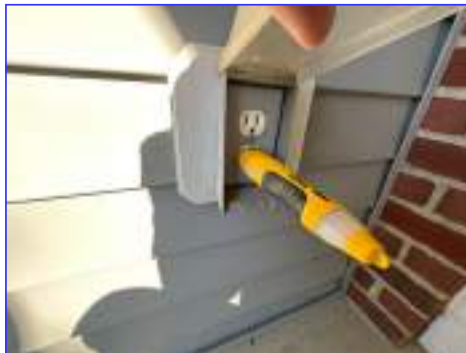
The outlets are functional and include ground-fault protection

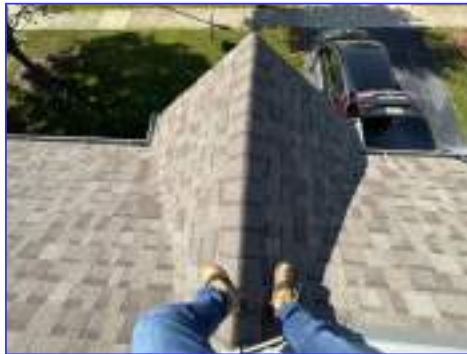
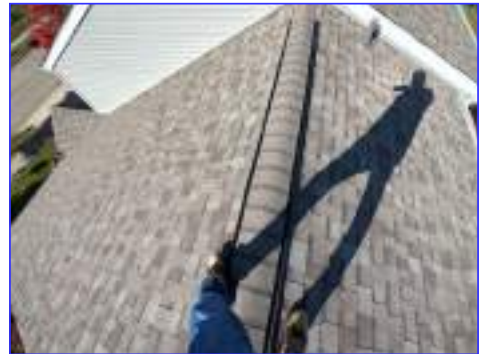
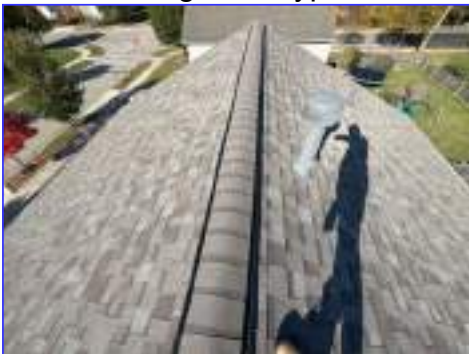
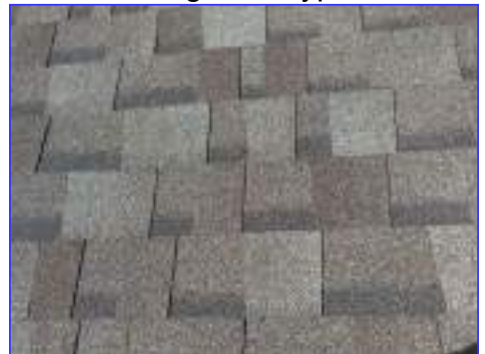
The roof shows normal wear for its age and type.

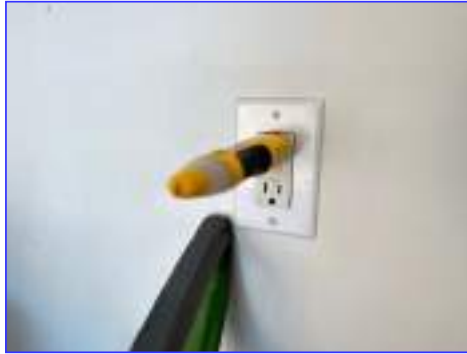
The outlets are functional and include ground-fault protection

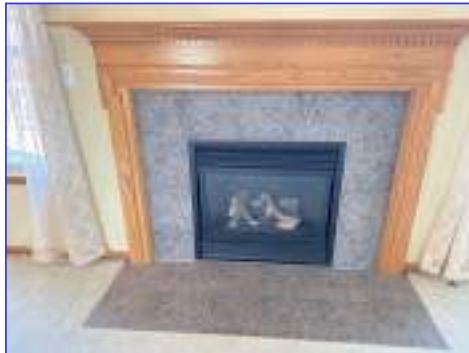
- Pilot light "off" at time of inspection. Lighting of pilot lights is not within the scope of inspection. Buyer is therefore urged to ensure satisfactory operation of this unit prior to close.

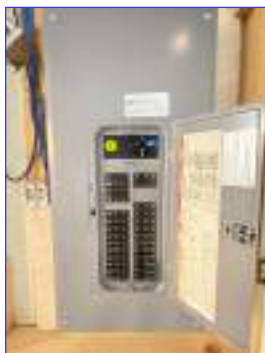
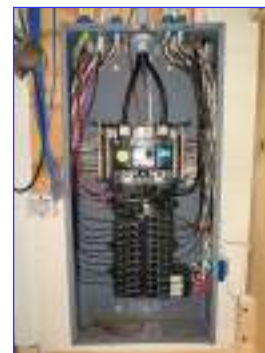
The panel and its components have no visible deficiencies

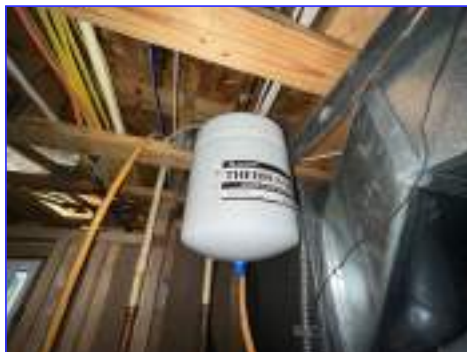
An expansion tank is installed to allow for thermal expansion of water in the plumbing pipes. The expansion tank appeared to be properly installed and in serviceable condition but was not tested.

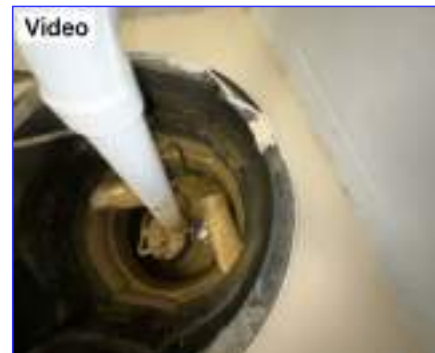
- The sump pump is accessible and in acceptable condition.
- The sump pump discharge pipe is damaged, improperly repaired with duct tape and should be serviced or replaced.

The sump pump discharge pipe is damaged, improperly repaired with duct tape and should be serviced or replaced.

The sump pump is accessible and in acceptable condition.

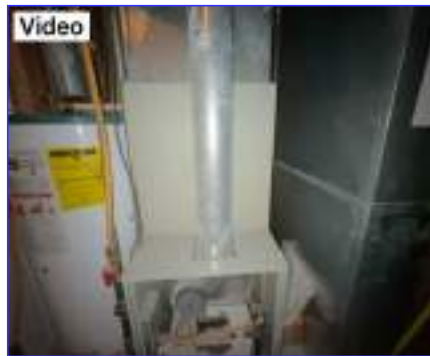
The vent pipes have no visible deficiencies.

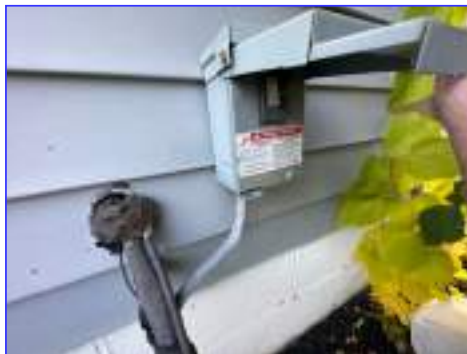
The electrical disconnect at the condensing coils are functional.

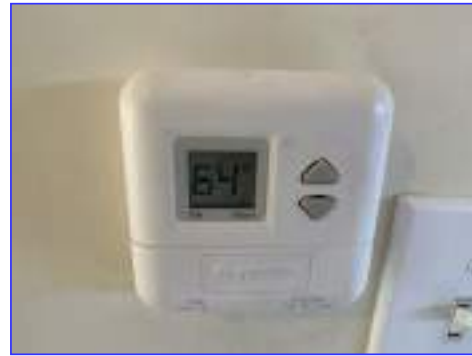
Thermostat settings upon completion

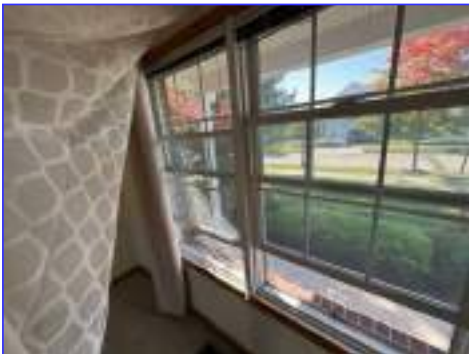
The windows are functional and appear to be in satisfactory condition

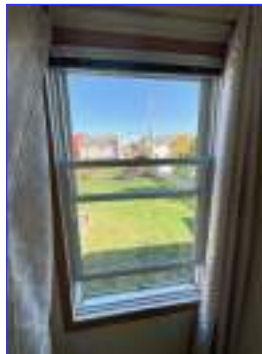
The windows are functional and appear to be in satisfactory condition

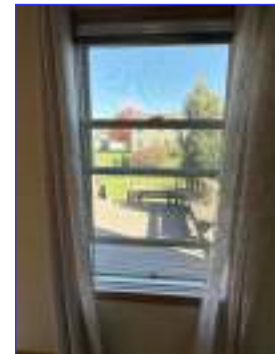
The windows are functional and appear to be in satisfactory condition

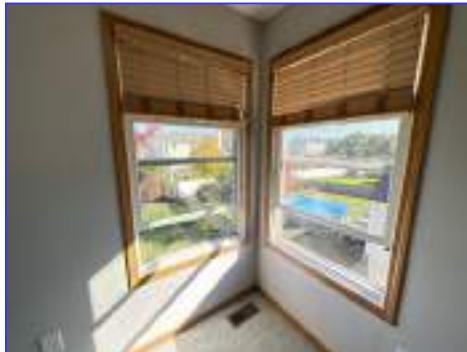
The windows are functional and appear to be in satisfactory condition

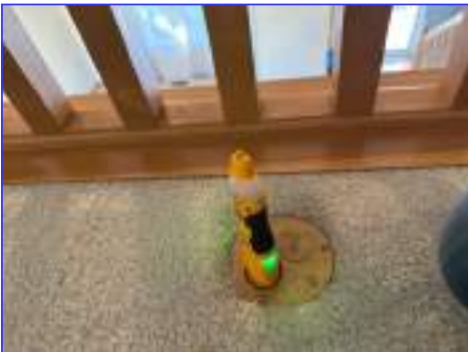
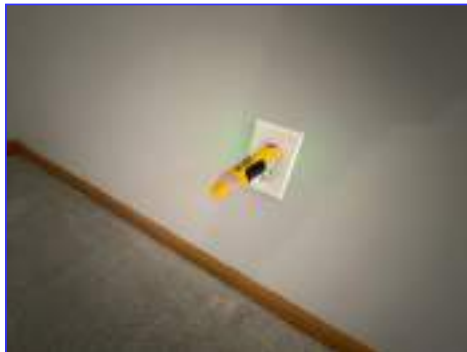
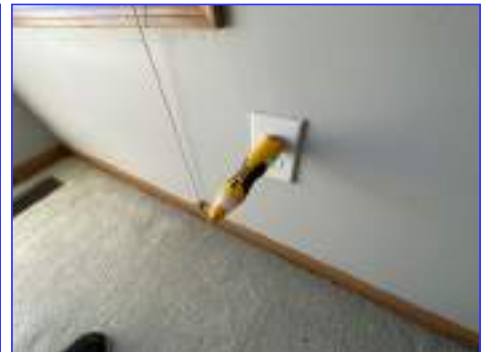
The outlets that were tested are functional.

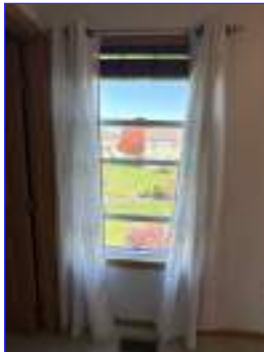
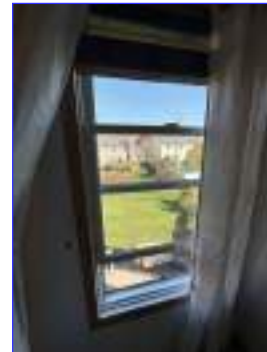
The windows are functional and appear to be in satisfactory condition

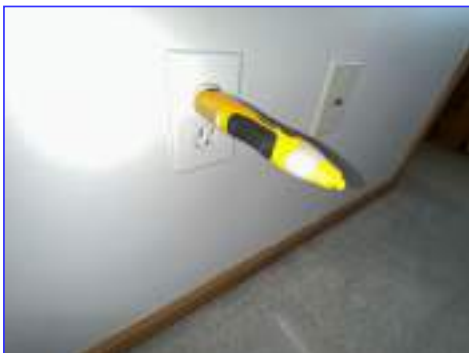
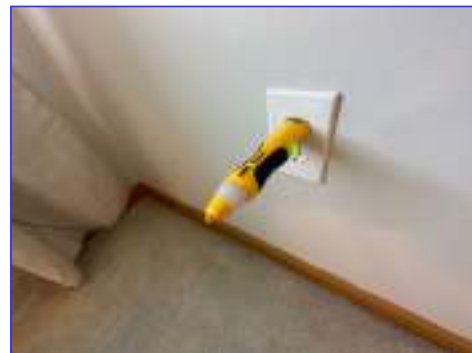
The outlets that were tested are functional.

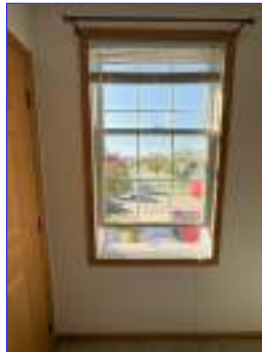
The windows are functional and appear to be in satisfactory condition

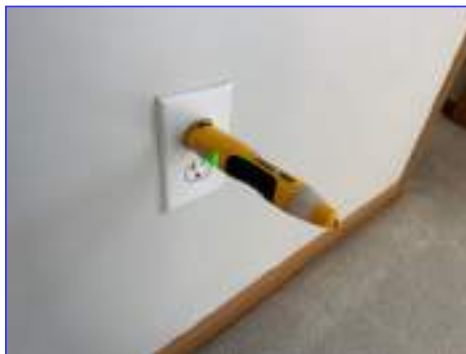
The outlets that were tested are functional.

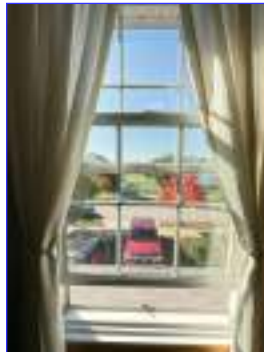
The windows are functional and appear to be in satisfactory condition

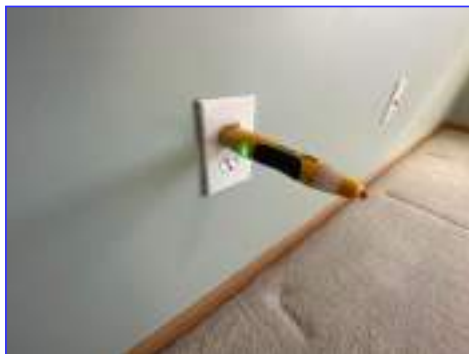
The outlets that were tested are functional.

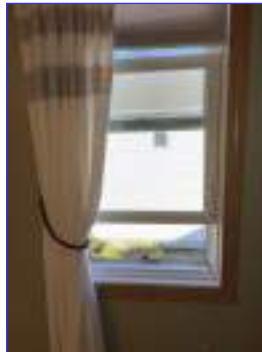
The windows are functional and appear to be in satisfactory condition

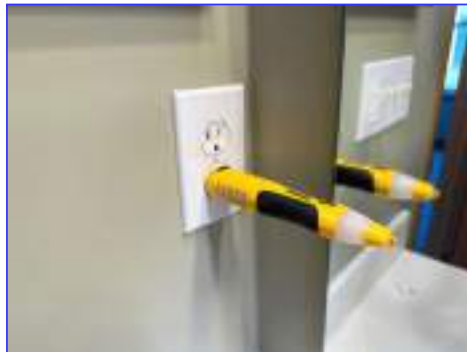
The outlets are functional and include ground-fault protection

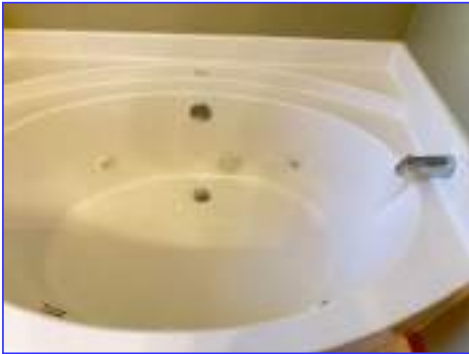
The tub, fixtures and hardware are in satisfactory condition with no visible deficiencies.

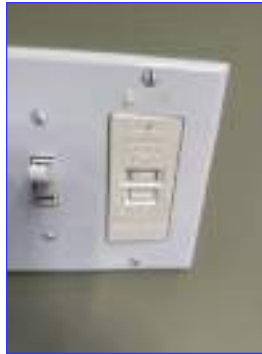
Tub is GFCI protected

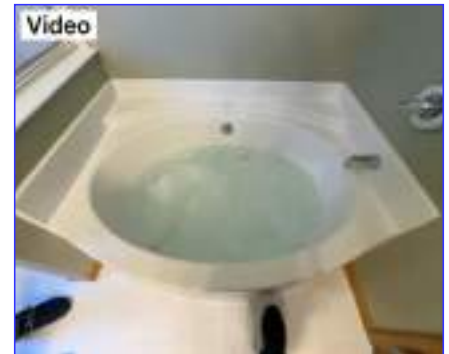
The whirlpool tub is functional

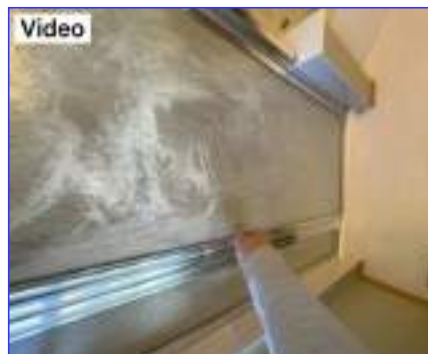
The shower, shower surround, fixtures and hardware are in satisfactory condition with no visible deficiencies.

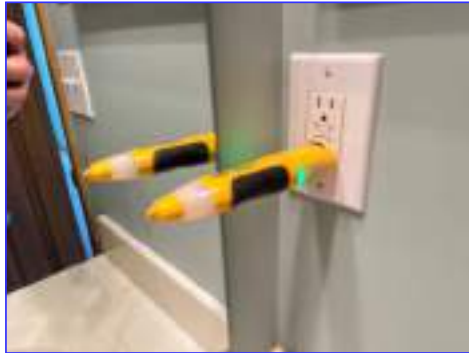
The outlets are functional and include ground-fault protection

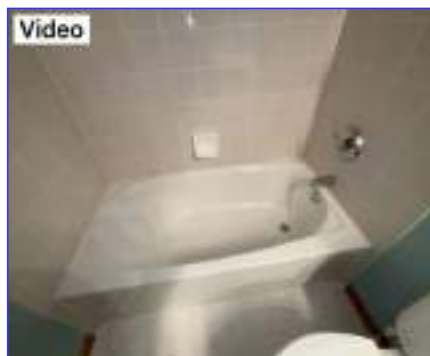
The tub shower, shower surround, fixtures and hardware are in satisfactory condition with no visible deficiencies.

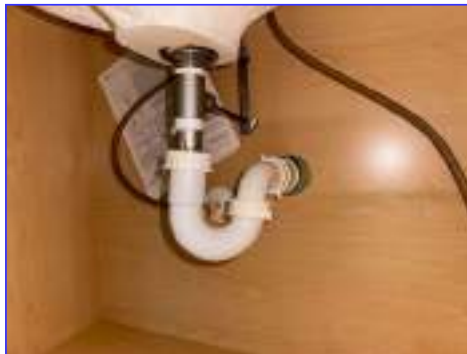
The drain assembly appears to be in satisfactory condition with no visible leaks or deficiencies.

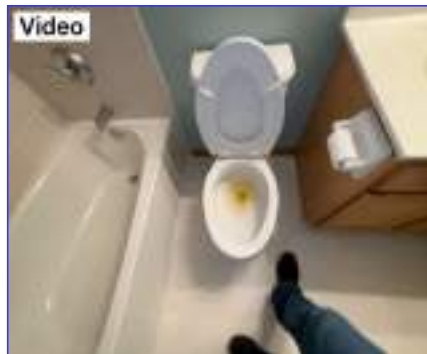
The toilet is functional with no visible leaks or deficiencies.

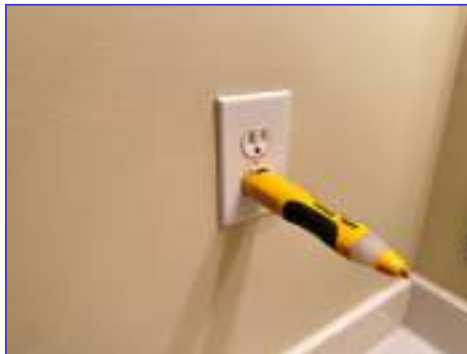
The outlets are functional and include ground-fault protection

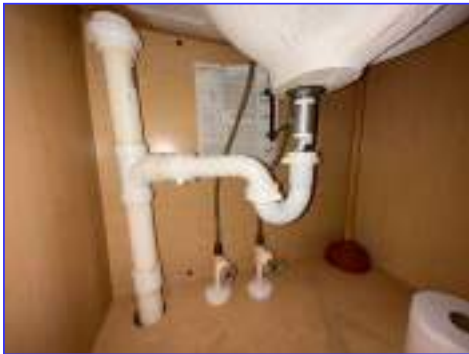
- The sink drain is slow or partially blocked and should be serviced.

||4||The sink drain is slow or partially blocked and should be serviced.

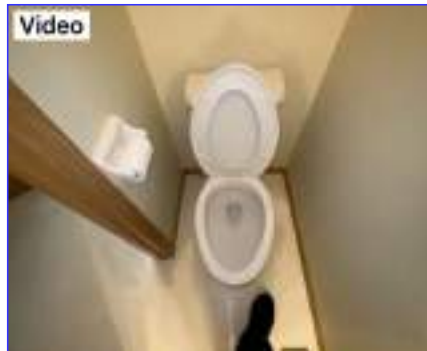
The toilet is functional with no visible leaks or deficiencies.

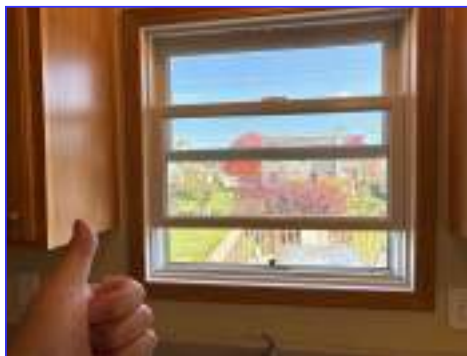
The windows are functional and appear to be in satisfactory condition

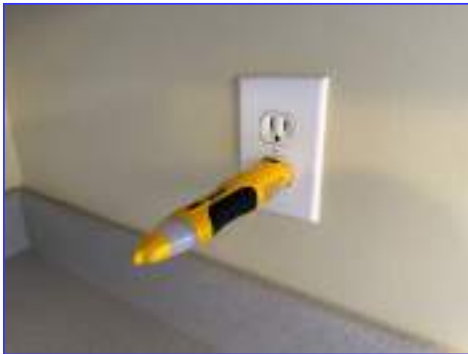
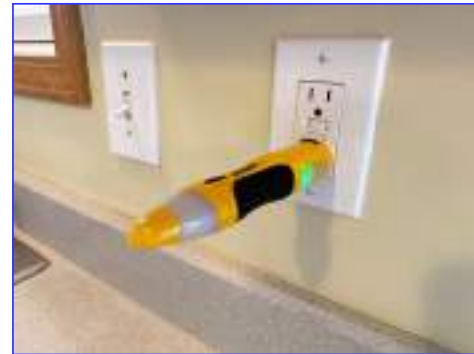
The outlets are functional and include ground-fault protection The outlets are functional and include ground-fault protection

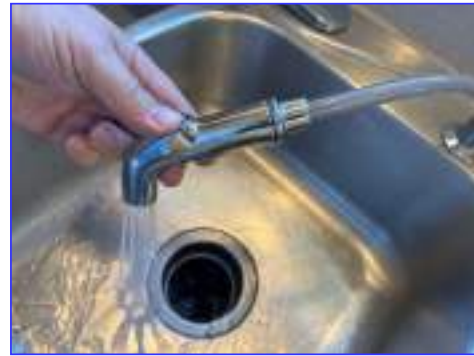
The sprayer is functional.

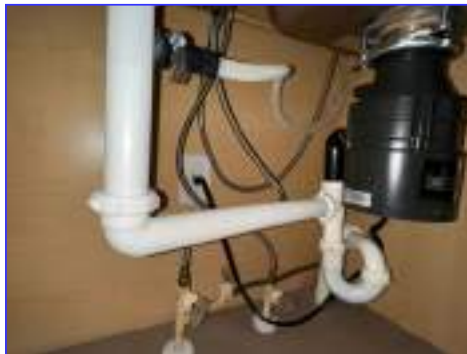
The drain assembly appears to be in satisfactory condition with no visible leaks or deficiencies.

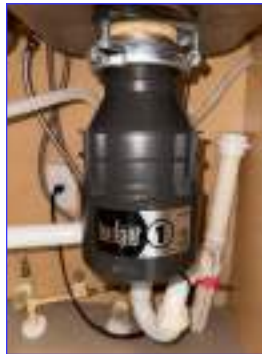
The garbage disposal is functional.

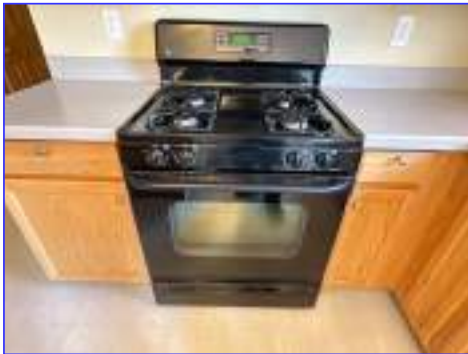
The cooktop and oven are functional.

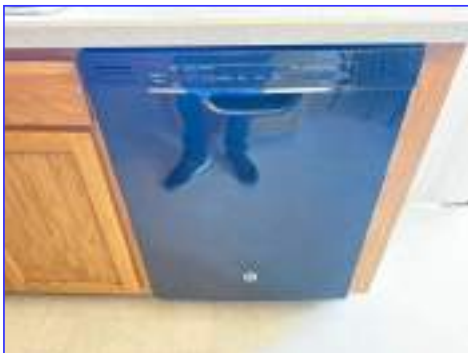
The dishwasher is functional.

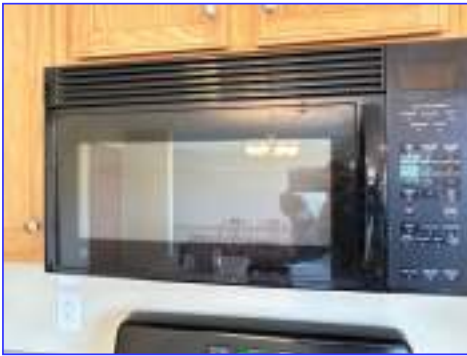
The built-in microwave is functional.

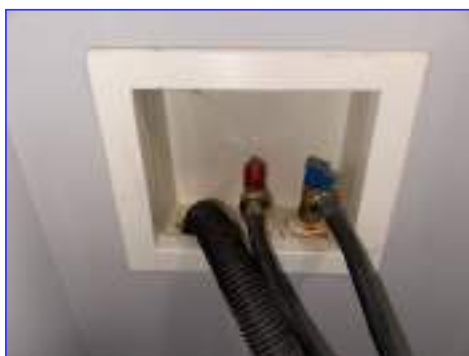
- Washer hook ups observed. We do not disconnect the supply hoses to the washer, nor do we operate the valves. These can leak at any time and should be considered a part of normal maintenance.

Washer hookup

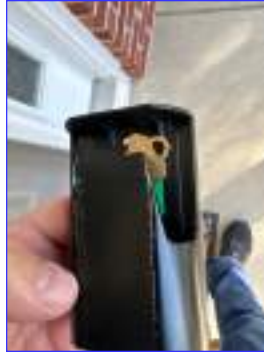
Key back on the cradle
