# Property Inspection Report

Your Happy Home,  
Your Town, OH

DATE OF INSPECTION: 10/12/2023

**ClearVIEW**  
INSPECTION GROUP

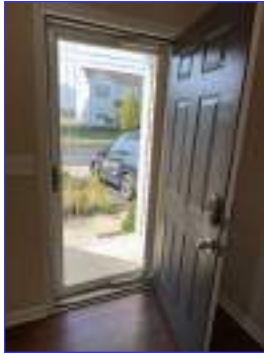
The exterior door(s) are in satisfactory condition

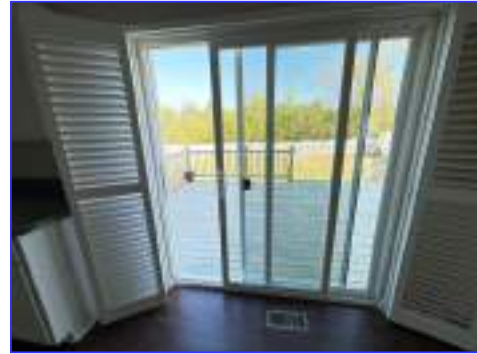
The exterior door(s) are in satisfactory condition

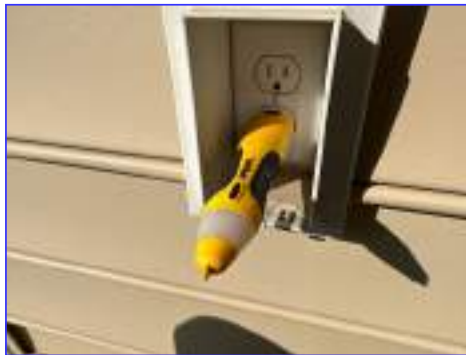
The outlets are functional and include ground-fault protection

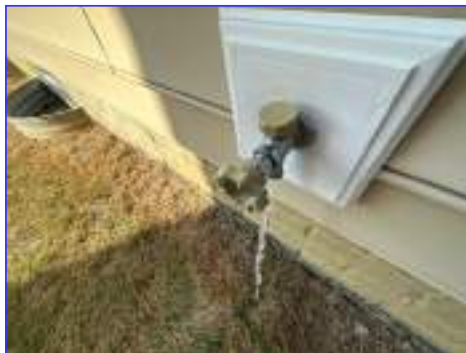
The exterior faucets are functional.

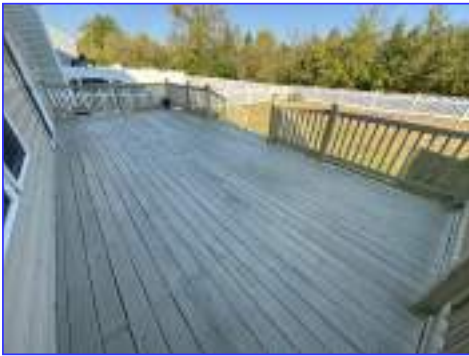
- **Lose guardrail-**

**The deck guardrail assemblies were loose and should be made secure by a qualified contractor.**

The deck is in acceptable condition.

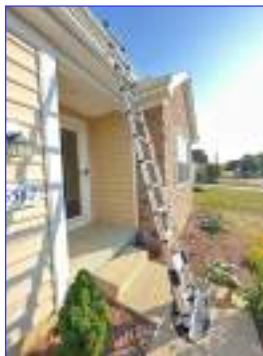
Walked the roof - The Inspector inspected the roofing materials and components by walking the roof surface

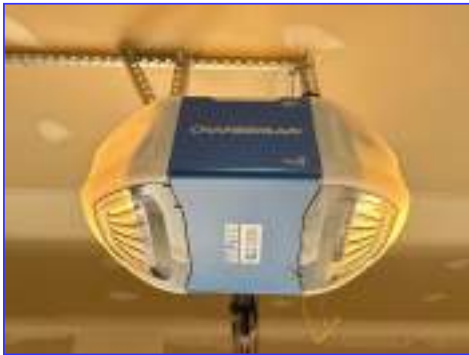
The garage door opener is functional.

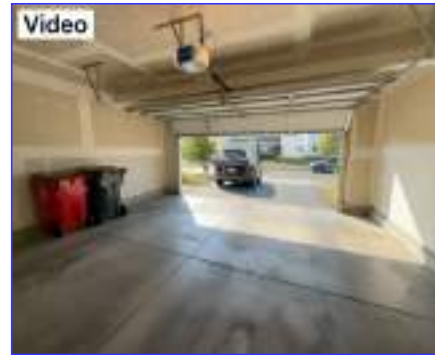
The garage door opener is functional.

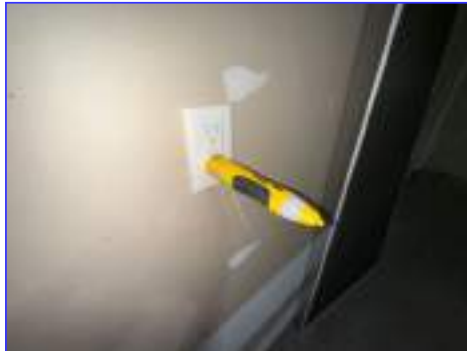
The outlets are functional and include ground-fault protection

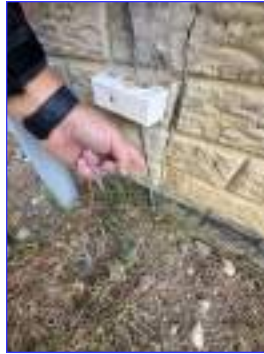
The panel is grounded to a driven rod.

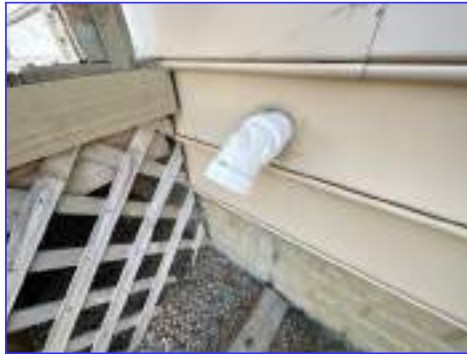
At the time of the inspection, the Inspector observed no deficiencies in the condition of the exhaust flue for this gas-fired water heater.

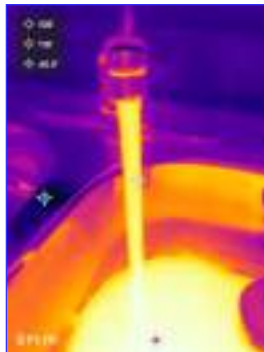
- The hot water temperature was (110) degrees at the time of inspection

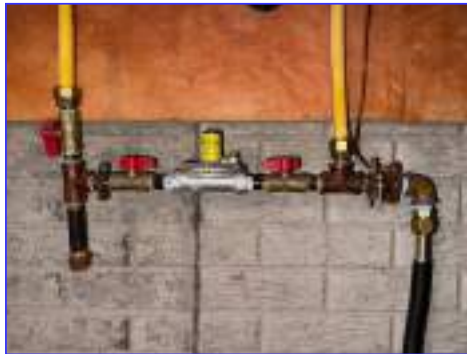
The visible portions of the gas pipes appear to be in acceptable condition.

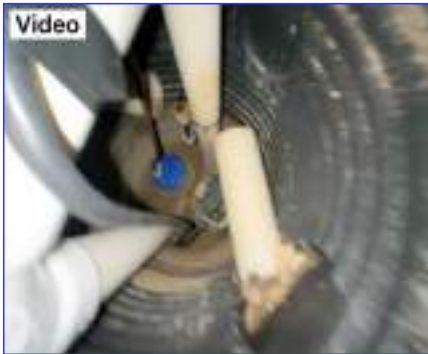
The sump pump is accessible and in acceptable condition.

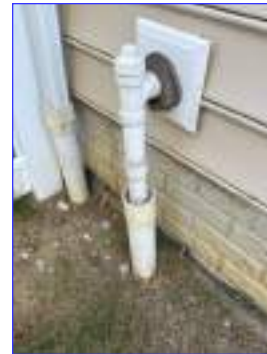
The visible portions of the sump pump discharge pipe is in acceptable condition.

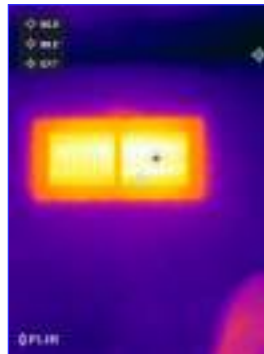
The furnace is functional

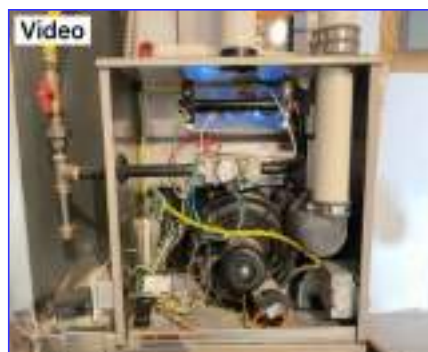
- Combustion chamber OK- Conditions in the furnace combustion chamber appeared to be acceptable at the time of the inspection. Some of the combustion chamber was not visible. A full evaluation of the combustion chamber would require the services of a qualified heating, ventilation and air-conditioning (HVAC) contractor.

Combustion chamber OK

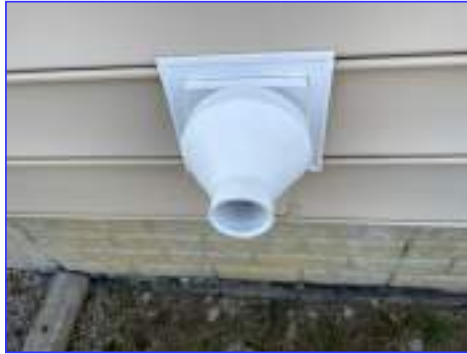
The vent pipes have no visible deficiencies.

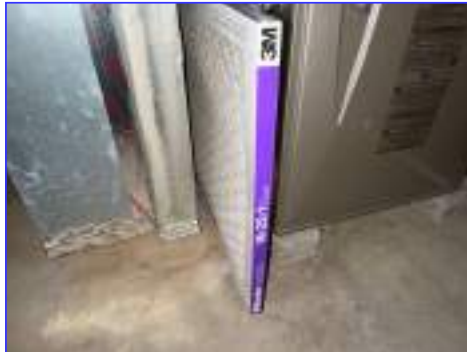
The return-air compartments are in acceptable condition.

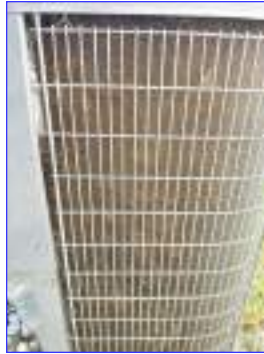
Coils are dirty or full of debris, suggest cleaning coils regularly for proper operation.

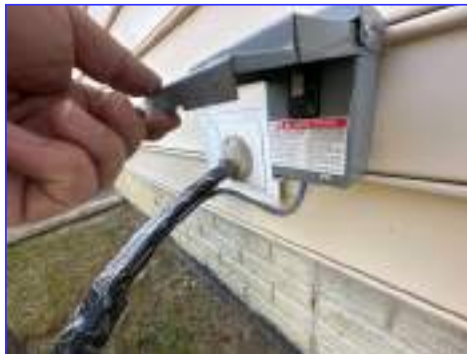
The electrical disconnect at the condensing coils are functional.

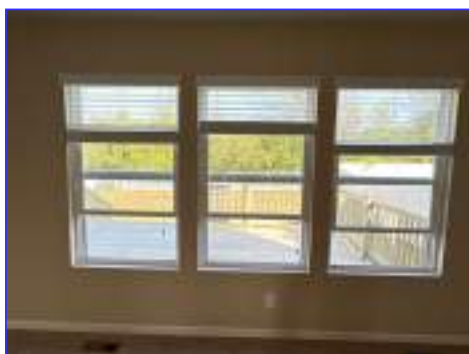
The windows are functional and appear to be in satisfactory condition

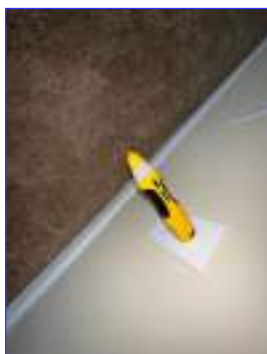
The outlets that were tested are functional.

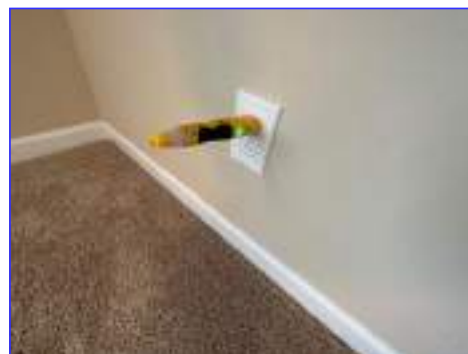
The outlets that were tested are functional.

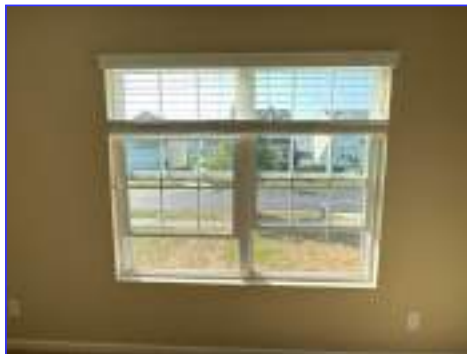
The windows are functional and appear to be in satisfactory condition

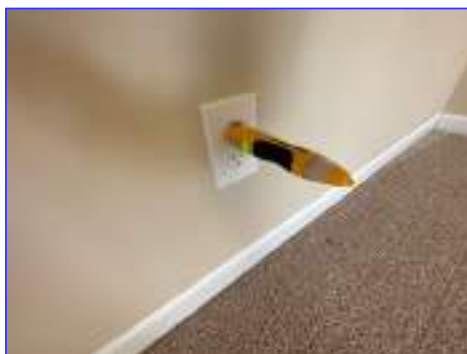
The outlets that were tested are functional.

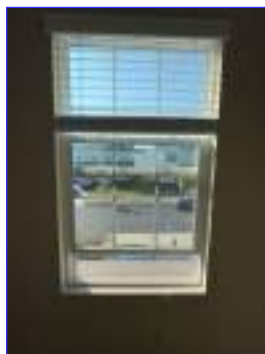
The windows are functional and appear to be in satisfactory condition

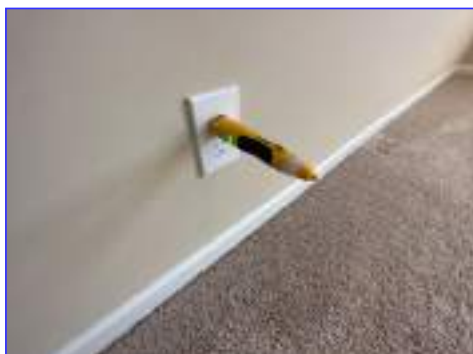
The outlets that were tested are functional.

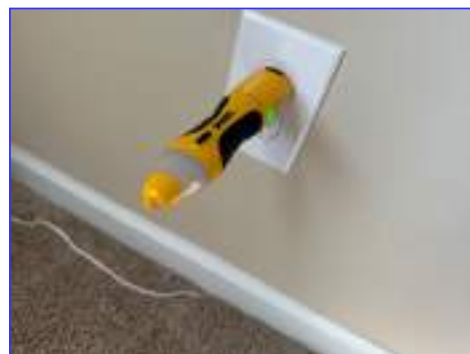
The outlets that were tested are functional.

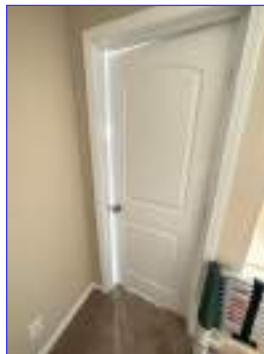
||4||Door sticks, does not close, needs adjustment.

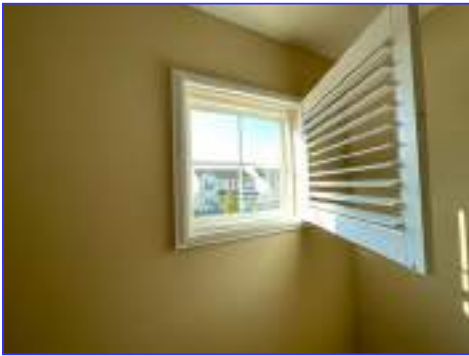
The windows are functional and appear to be in satisfactory condition

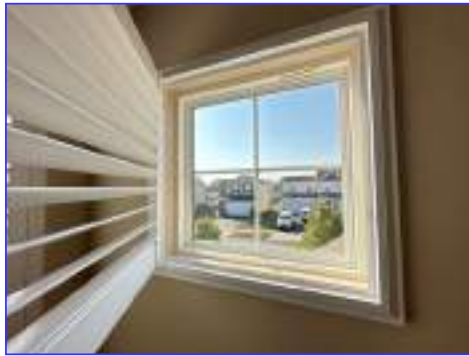
The windows are functional and appear to be in satisfactory condition

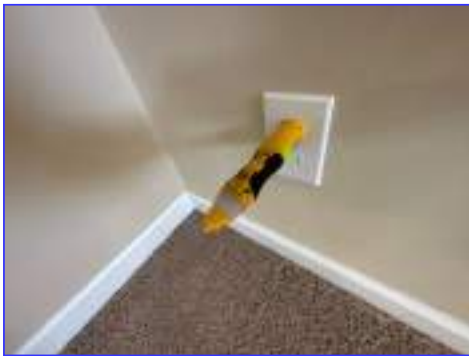
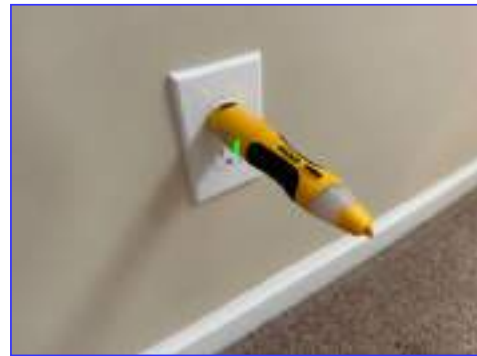
The outlets that were tested are functional.

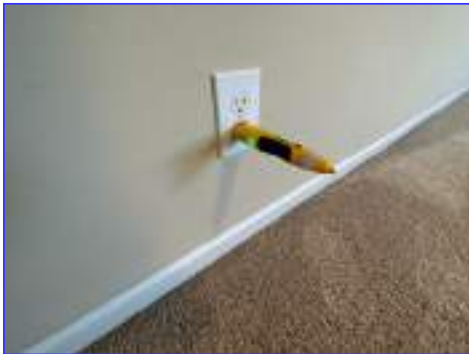
The outlets that were tested are functional.

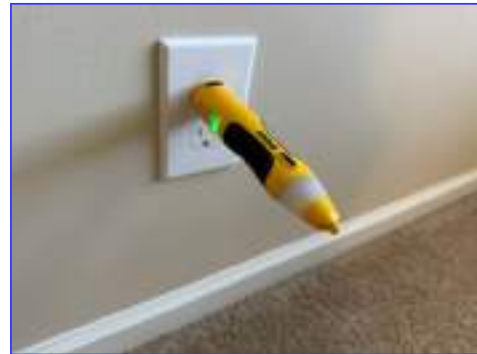
The outlets that were tested are functional.

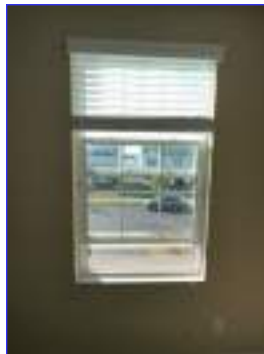
The windows are functional and appear to be in satisfactory condition

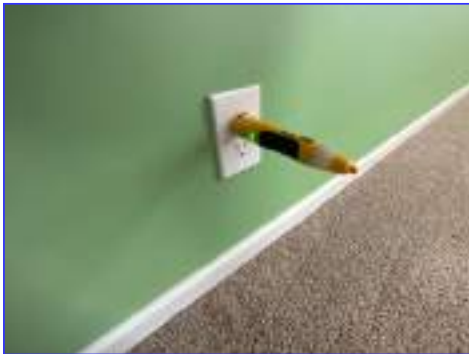
The outlets that were tested are functional.

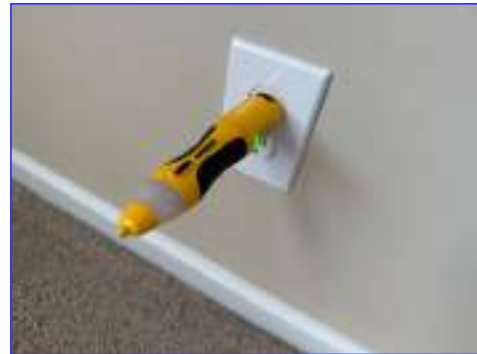
The outlets that were tested are functional.

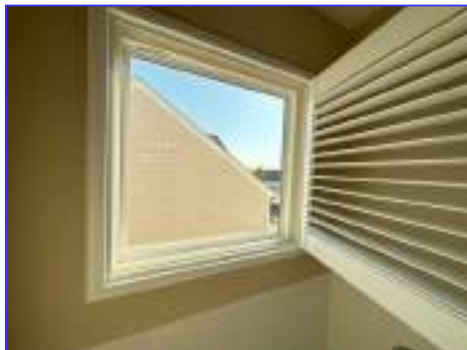
The windows are functional and appear to be in satisfactory condition

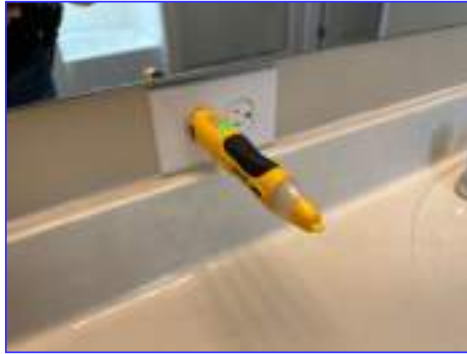
The outlets are functional and include ground-fault protection

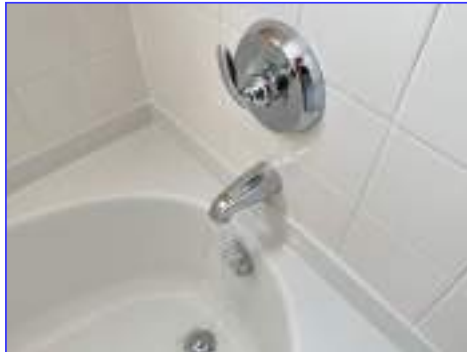
The tub, fixtures and hardware are in satisfactory condition with no visible deficiencies.

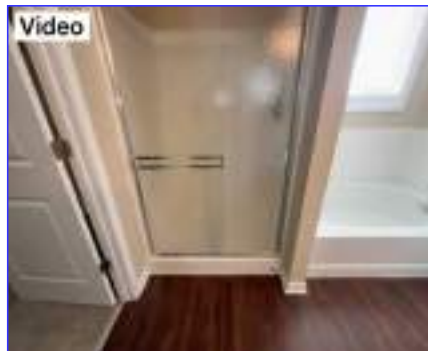
The shower, shower surround, fixtures and hardware are in satisfactory condition with no visible deficiencies.

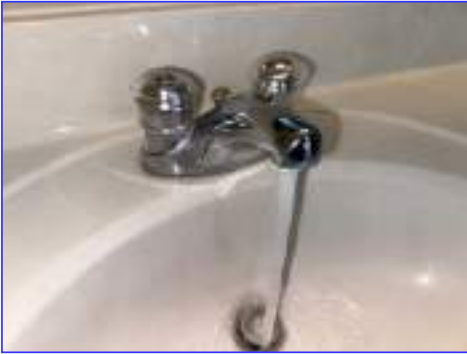
The Faucet is functional.

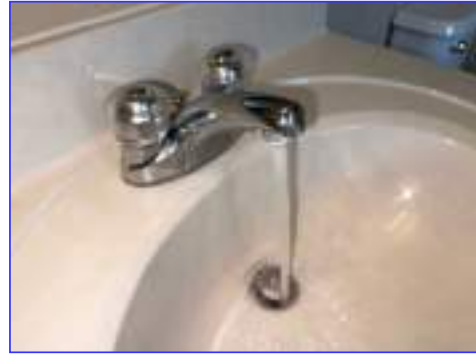
The Faucet is functional.

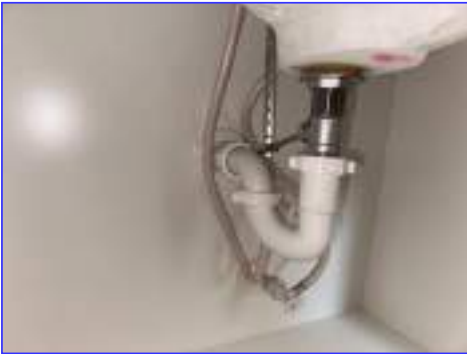
The drain assembly appears to be in satisfactory condition with no visible leaks or deficiencies.

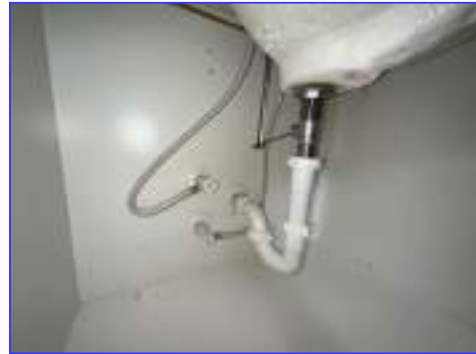
The drain assembly appears to be in satisfactory condition with no visible leaks or deficiencies.

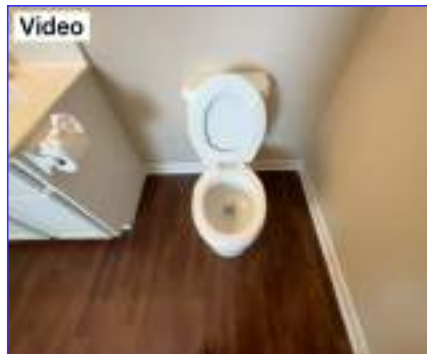
The toilet is functional with no visible leaks or deficiencies.

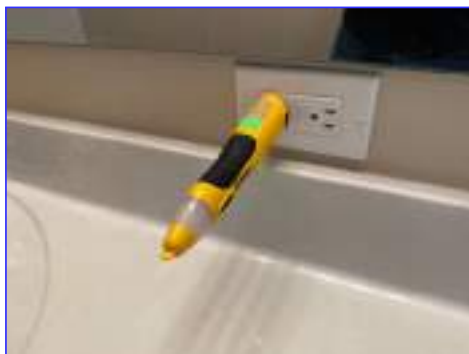
The outlets are functional and include ground-fault protection

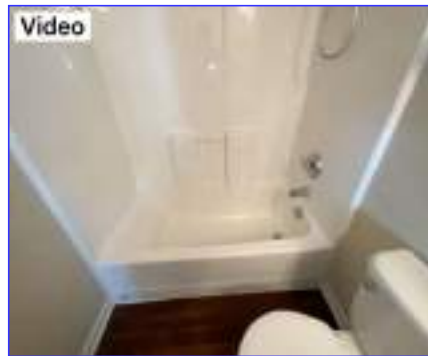
The tub shower, shower surround, fixtures and hardware are in satisfactory condition with no visible deficiencies.

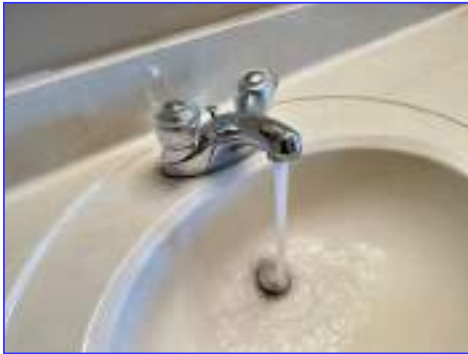
The Faucet is functional.

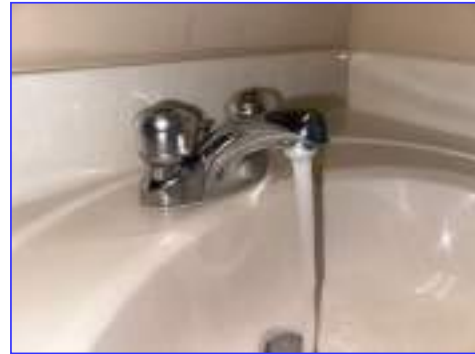
The Faucet is functional.

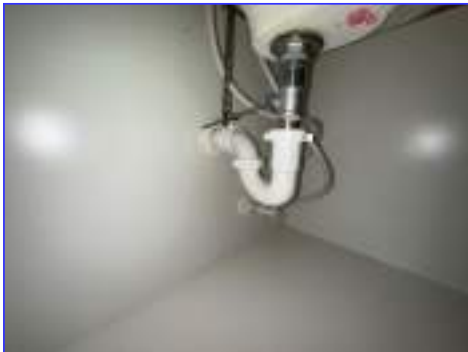
The drain assembly appears to be in satisfactory condition with no visible leaks or deficiencies.

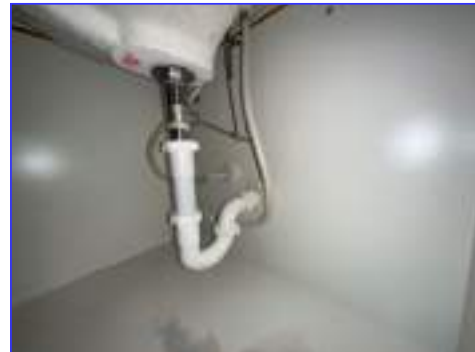
The drain assembly appears to be in satisfactory condition with no visible leaks or deficiencies.

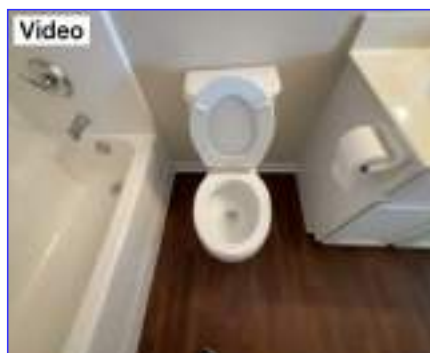
The toilet is functional with no visible leaks or deficiencies.

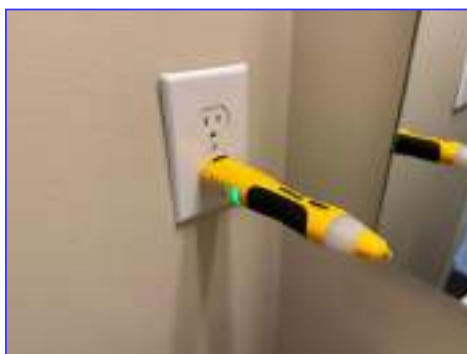
The outlets are functional and include ground-fault protection

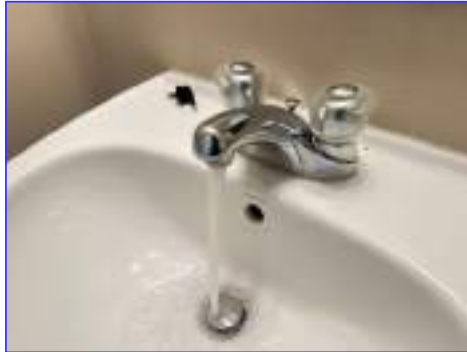
The Faucet is functional.

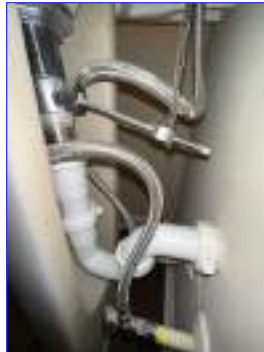
The drain assembly appears to be in satisfactory condition with no visible leaks or deficiencies.

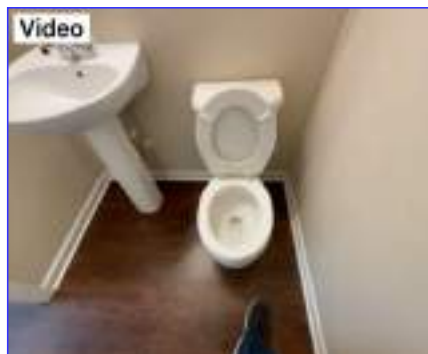
The toilet is functional with no visible leaks or deficiencies.

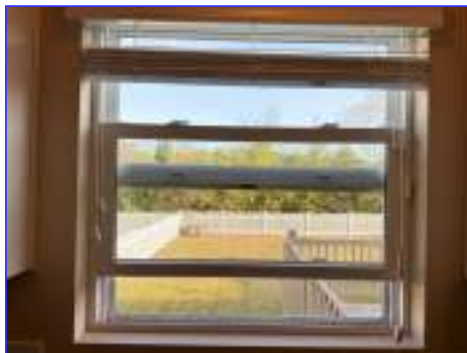
The windows are functional and appear to be in satisfactory condition

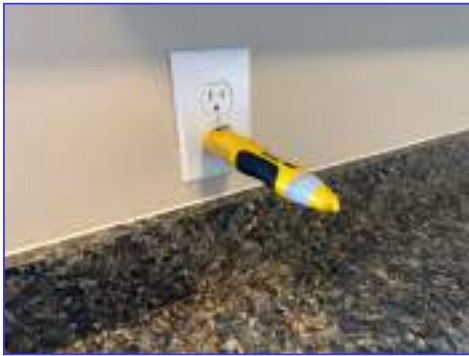
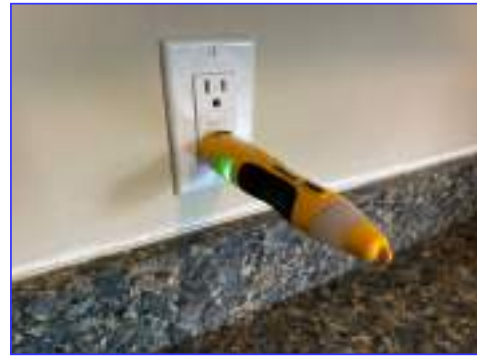
The outlets are functional and include ground-fault protection

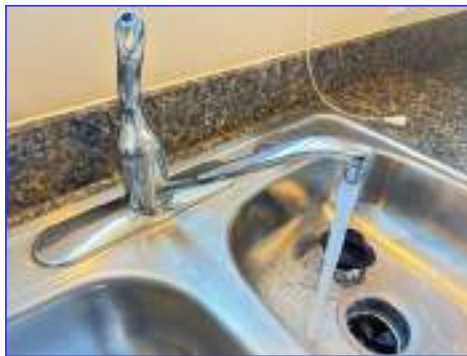
The Faucet is functional.

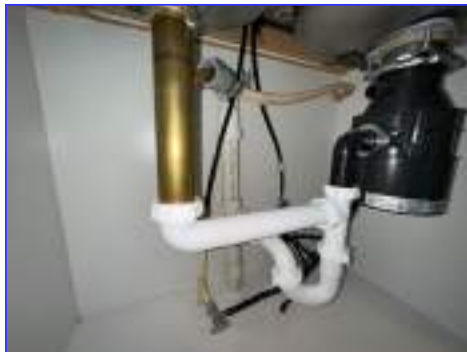
The drain assembly appears to be in satisfactory condition with no visible leaks or deficiencies.

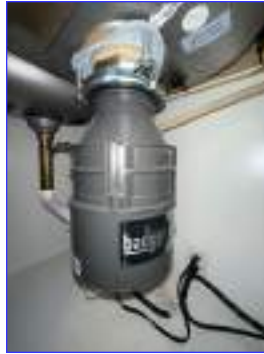
The garbage disposal is functional.

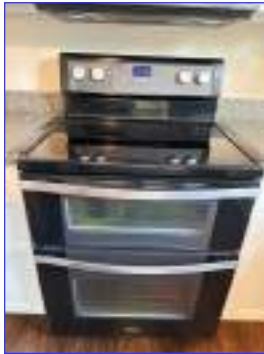
The cooktop and oven are functional.

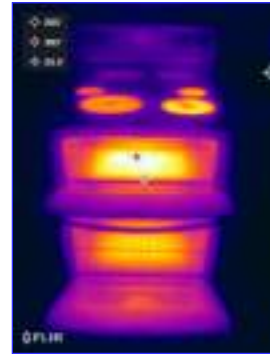
The cooktop and oven are functional.

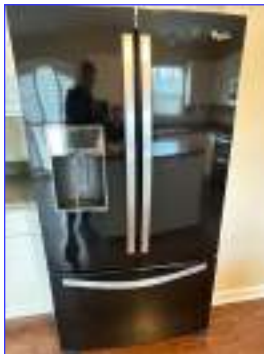
The refrigerator and freezer are functional.

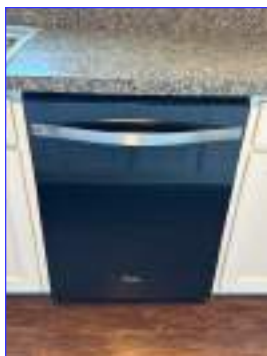
The dishwasher is functional.

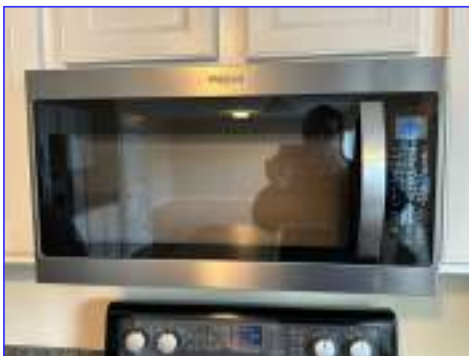
The built-in microwave is functional.

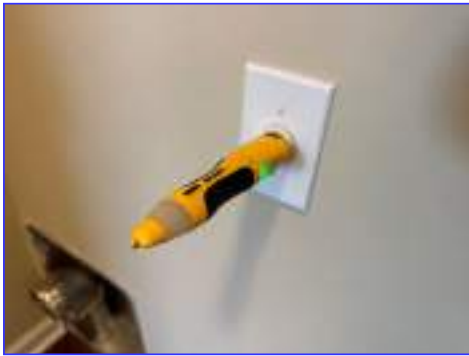
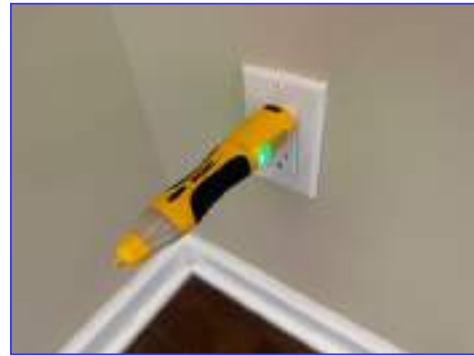
The outlets are functional and include ground-fault protection
